## Strafford Town Office

Strafford, Vermont

Reference: Structural Inspection of Strafford Town Hall Building

Reference: Structural Inspection of Strafford Town office Roof Damage  
227 Justin Morrill Highway, Strafford, Vermont

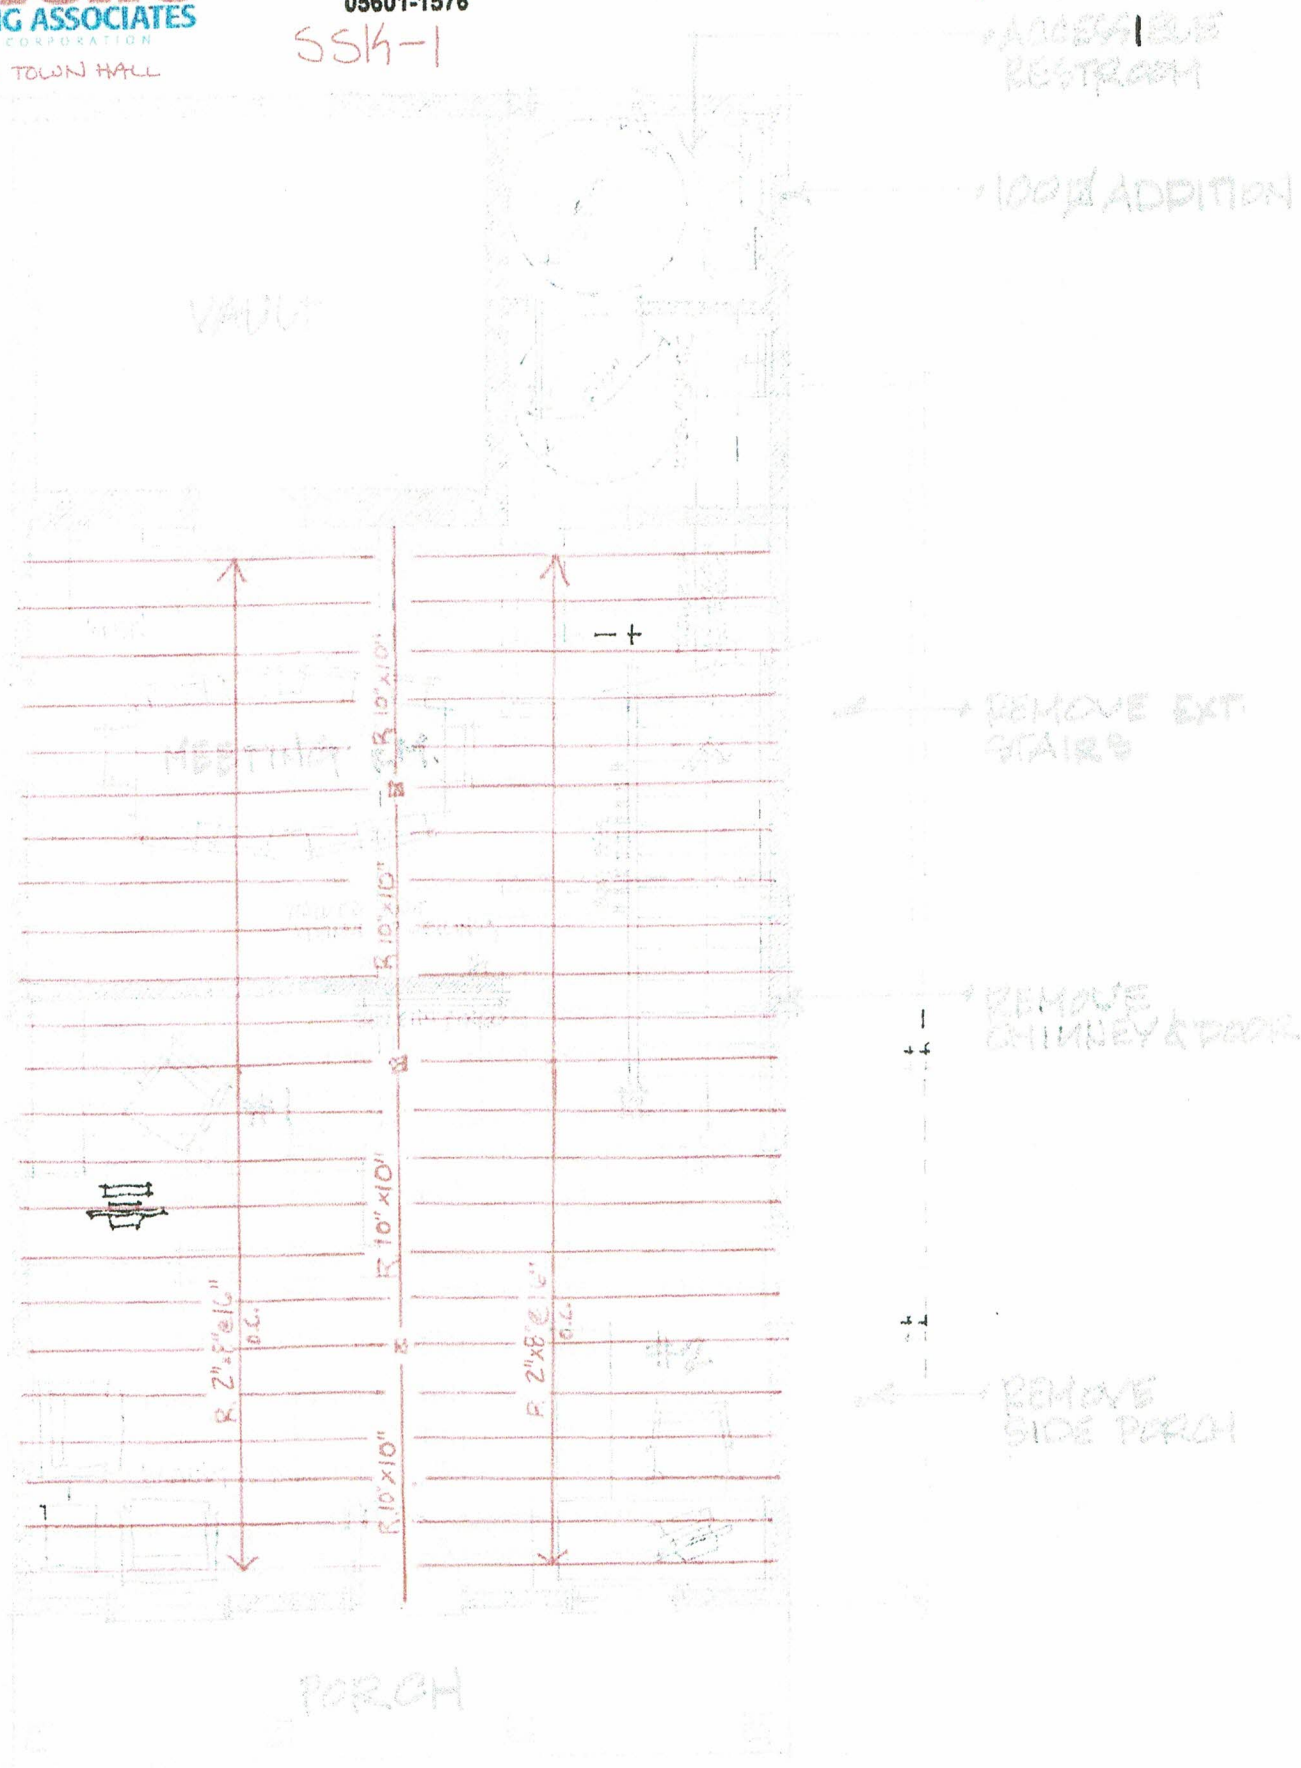
FIRST FLOOR FRAMING PLAN  
- EXISTING CONDITION

The first floor framing was partially exposed in the basement and the framing direction is shown in the attached SSK-1. The second floor framing was not exposed, but based upon nail patterns in the flooring and based upon visible columns in the first floor, we estimate the framing to be as shown in the attached sketch SSK-2. The roof framing could not be observed but based upon the shape of the second floor ceiling and roof, it appears that the roof is comprised of a tied rafter system that relies on the second floor framing to resist the outward thrust caused by the gambrel walls.

The first floor framing appears to be adequate for the expected floor loading but some rot was noted in the joists during the inspection. We recommend that a thorough inspection of the first floor framing be completed once adequate access is provided. Rotten members should be reinforced by sistering or replacement. Based upon our estimated thickness of the second floor framing and the estimated size and location of beams, we suspect that the existing second floor joists will be adequate for the expected use. The second floor beam will likely need to be reinforced especially if the existing post is relocated to create even longer spans. The addition of the stair opening will require reframing a portion of the floor to include the installation of new headers and trimmers around the opening. The installation of the stair will also require reinforcement of the interface between the roof and floor at the new opening. Preliminary assessment of the loads indicates that the reinforcements can be achieved with conventional or engineered lumber with some minor steel joinery. None of this reinforcement is beyond that expected in typical renovation work.

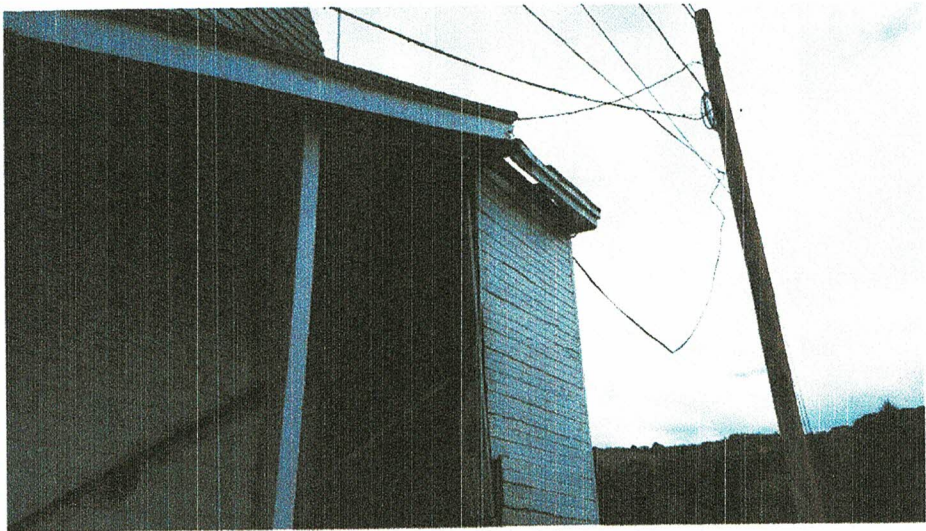
Photograph #1 – Roof damage

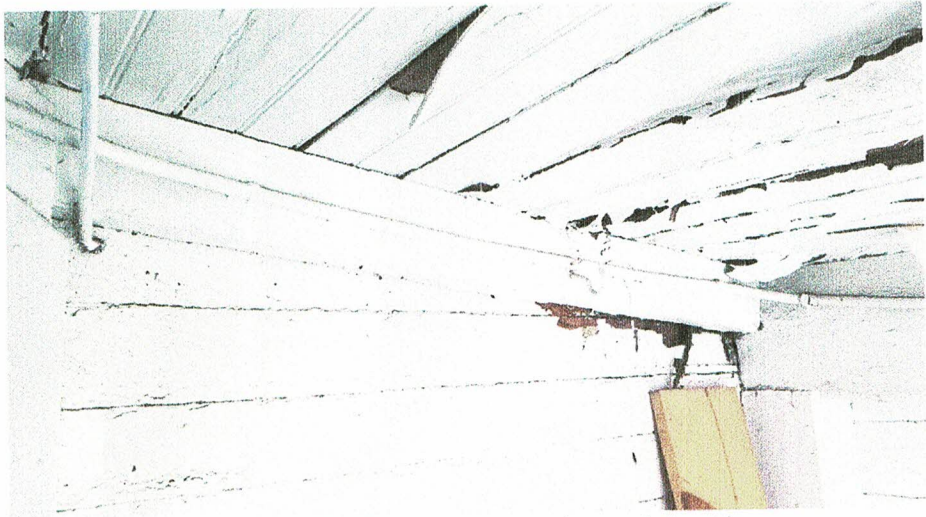
Photograph #2 – Broken rafter and damaged sheathing

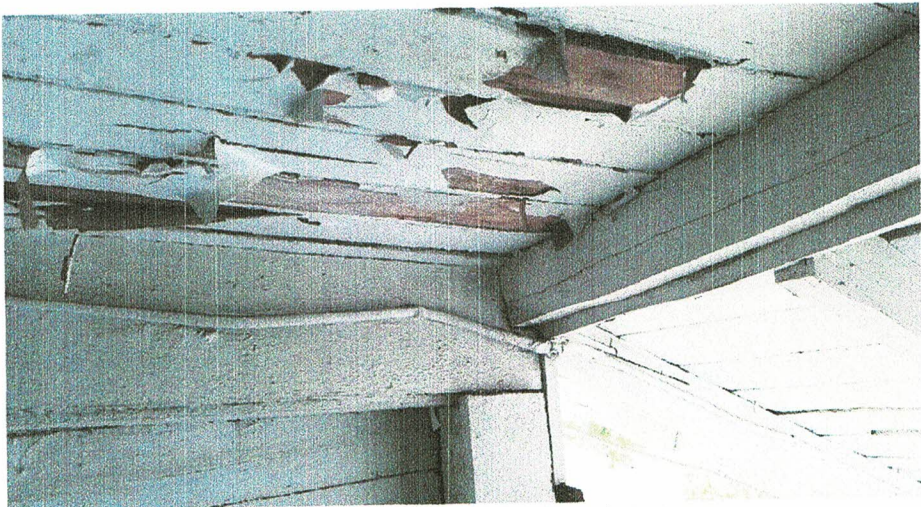
Photograph #3 – Roof sheathing damage

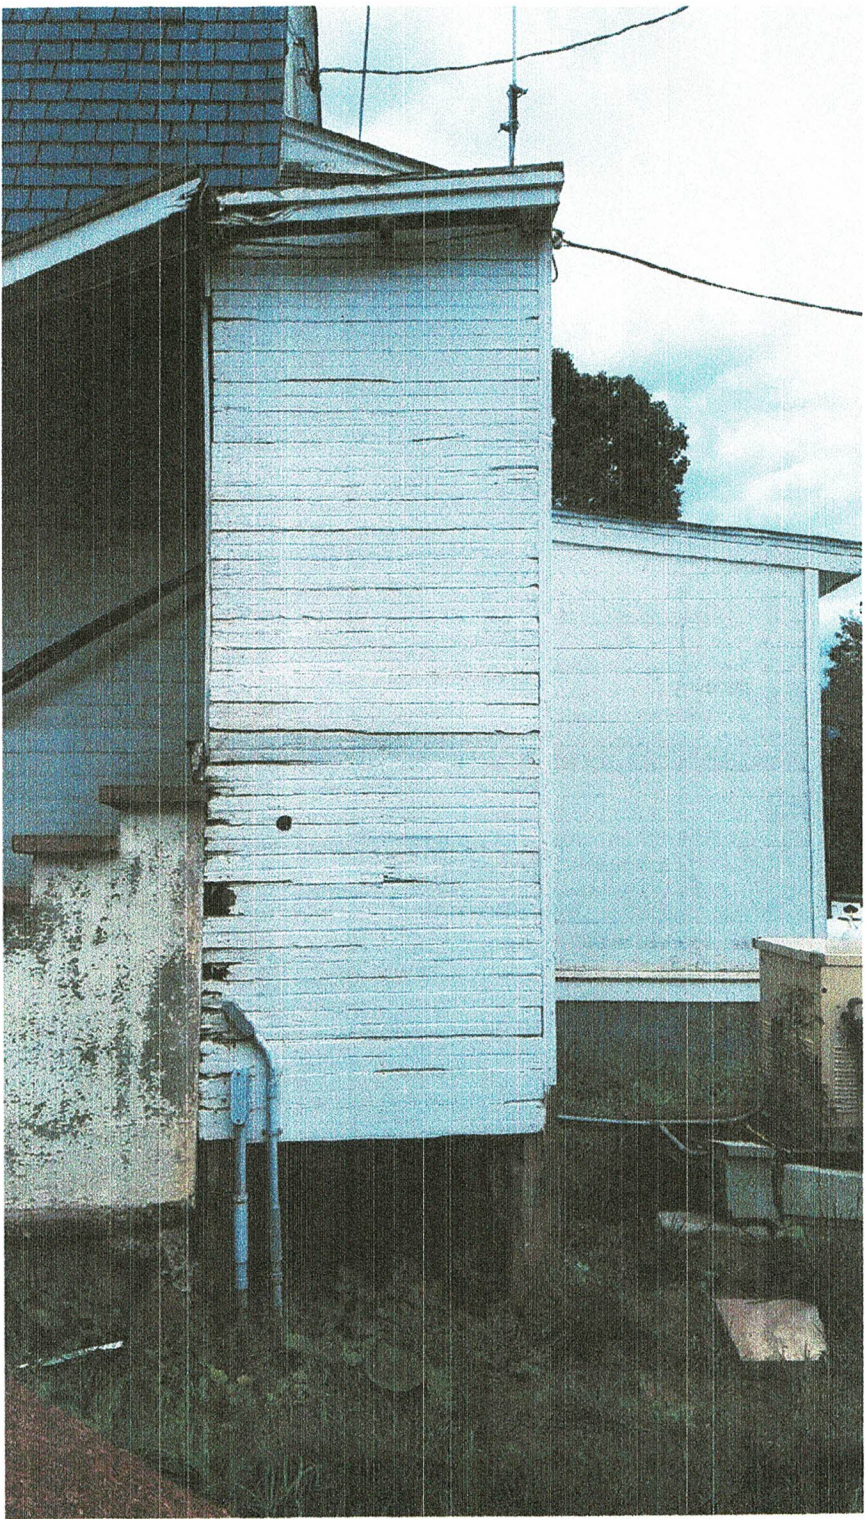
The damage to the stair and stair roof structure was isolated to the northwest corner of the structure (see photographs #1 thru #4). The pole damaged approximately 16 square feet of roofing, the roof sheathing in the corner of the building and the adjacent siding. In addition, the pole damaged one rafter and two supporting posts. As a result of the damage, we recommend that the repairs shown in the attached sketch SSK-1 be made to the building.

Photograph #4 – Siding damage, post damage, and roof damage

The recommended repairs include:

- Installation of three new 4x4 posts from foundation to roof structure
- Installation of new rafters
- Replace the existing T&G siding with new siding to match existing (we understand that future renovations are planned in this area. If desired a temporary sheathing such as T1-11 or a rail system could be installed in lieu of the T&G siding.)
- Replace existing T&G roofing with new T&G roofing (we understand that future renovations are planned in this area. If desired a less expensive sheathing such as 5/8" plywood could be installed in lieu of the T&G roofing.
- Repair the existing roofing.
- Replace any rotten framing discovered during installation of the new work in kind.
- Paint and finish the materials.

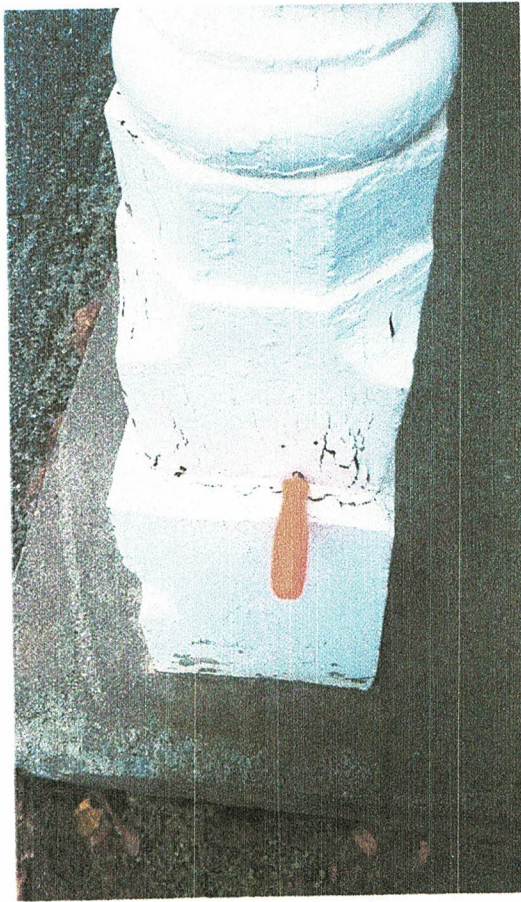
In addition to the north porch issues, the eastern entry porch has also degraded since my 2019 visit. Currently the porch posts have severe base rot and the front porch slab is heavily cracked. Furthermore, the sills and siding are buried below the front porch slab. Based upon the insertion of probes along the entry, it appears that sill rot has gotten significantly worse since the 2019 condition. In addition, it appears that regrading of the road shoulder to the northeast has directed additional water towards the porch, sill, and crawlspace.

Photograph #1 – Porch post base rot

- Regrade the site to direct surface water away from the building.
- Repair/replace the existing damaged/rotten porch posts.
- Replace the existing foundation of both the eastern and northern porches.
  - The base slab at the bottom of the northern porch stair requires immediate attention.
- Repair/replace/reinforce the existing sills along the north and east walls of the building.

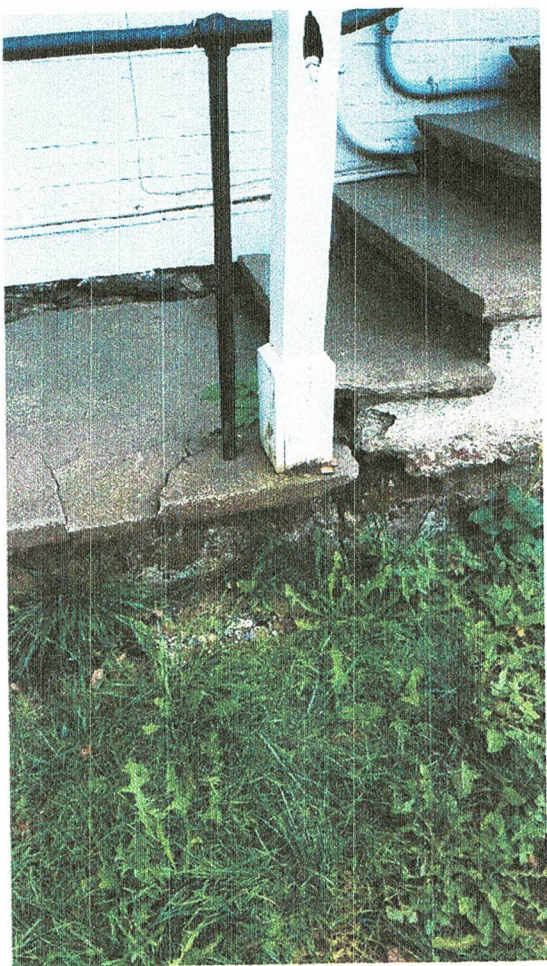
During review of the back-stair damage, I discovered that the north porch roof and the slab supporting it had both visibly degraded since my 2019 inspection. In my July 19, 2019 report concerning the building, the north porch was already in poor condition but at that time the porch was planned to be removed. The porch has continued to degrade and several of the posts are damaged and the exterior stair has continued to settle. In addition, grade against the building has been changed and as a result, water from a significant surface area is directed into the crawlspace. In our 2019 report we had recommended that the northern slab be removed and proper drainage provided to prevent further rot and water infiltration into the crawlspace. The current condition has made the crawlspace infiltration worse and has likely exacerbated rot and moisture conditions that already existing in the crawlspace.

Photograph #2 – Post damage at north porch

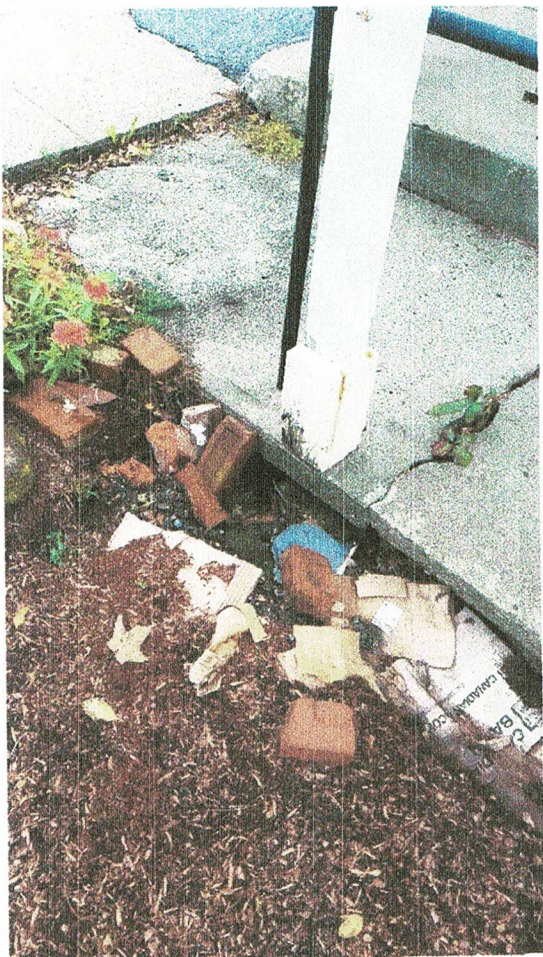
Photograph #3 – Post damage at north porch

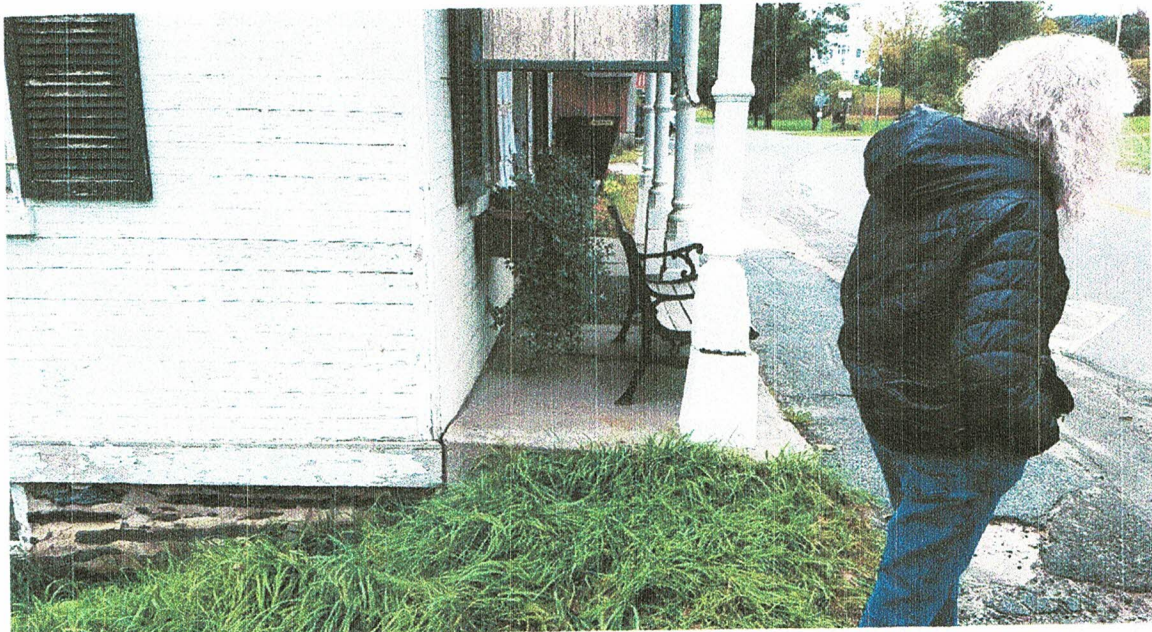
Photograph #4 – Eastern porch slope, pier movement, sill buried in concrete.

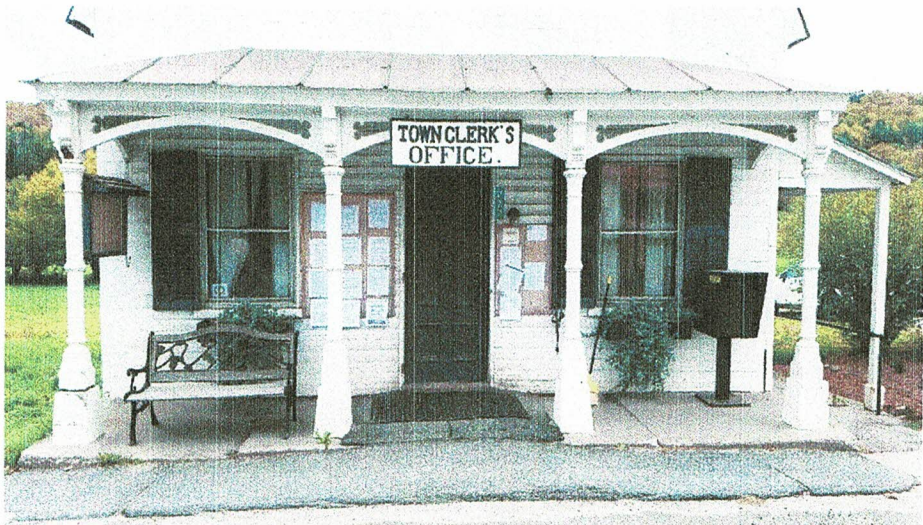
Photograph #5 – Eastern porch movement, eastern sill below grade, drainage towards building/crawlspace.

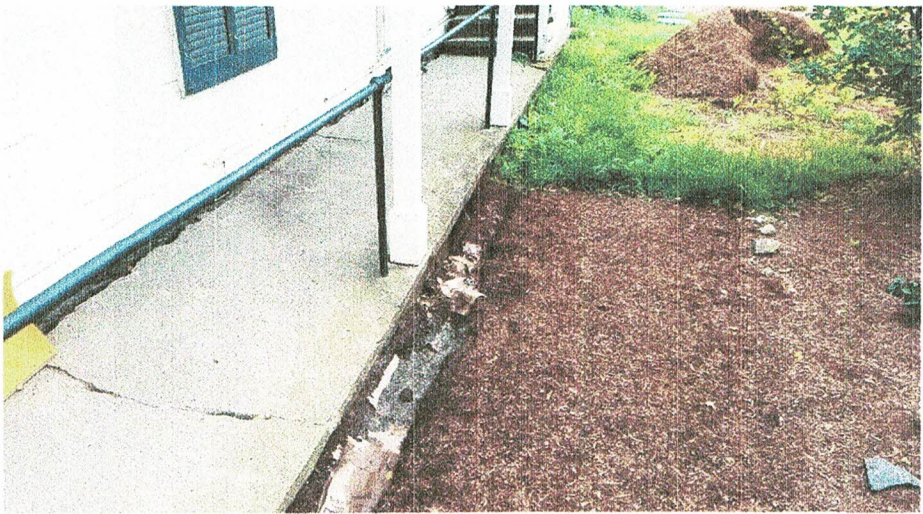
Photograph #6 – Drainage issues directed towards crawlspace access.

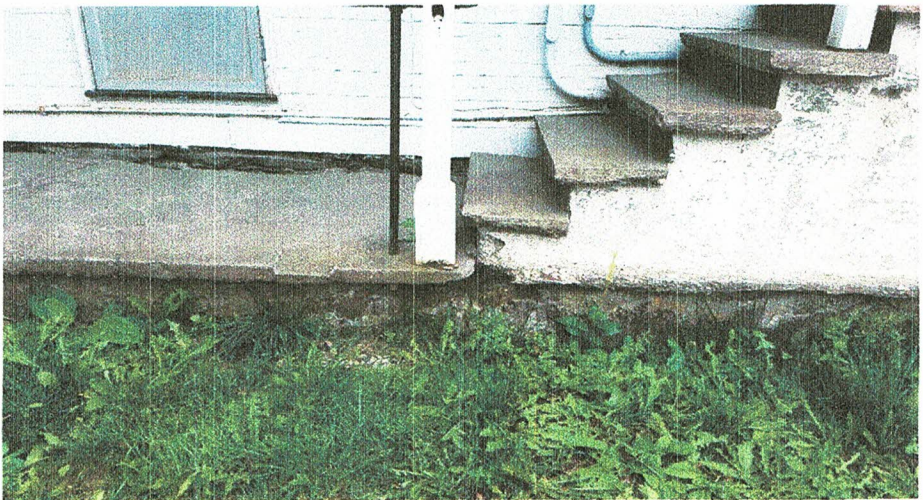
Photograph #7 – Column and north porch support issues
