# 1898 Adit Supplemental Information

## Elizabeth Mine Public Information Update - December 2020

## 2018 Sink Hole Near 1898 Adit

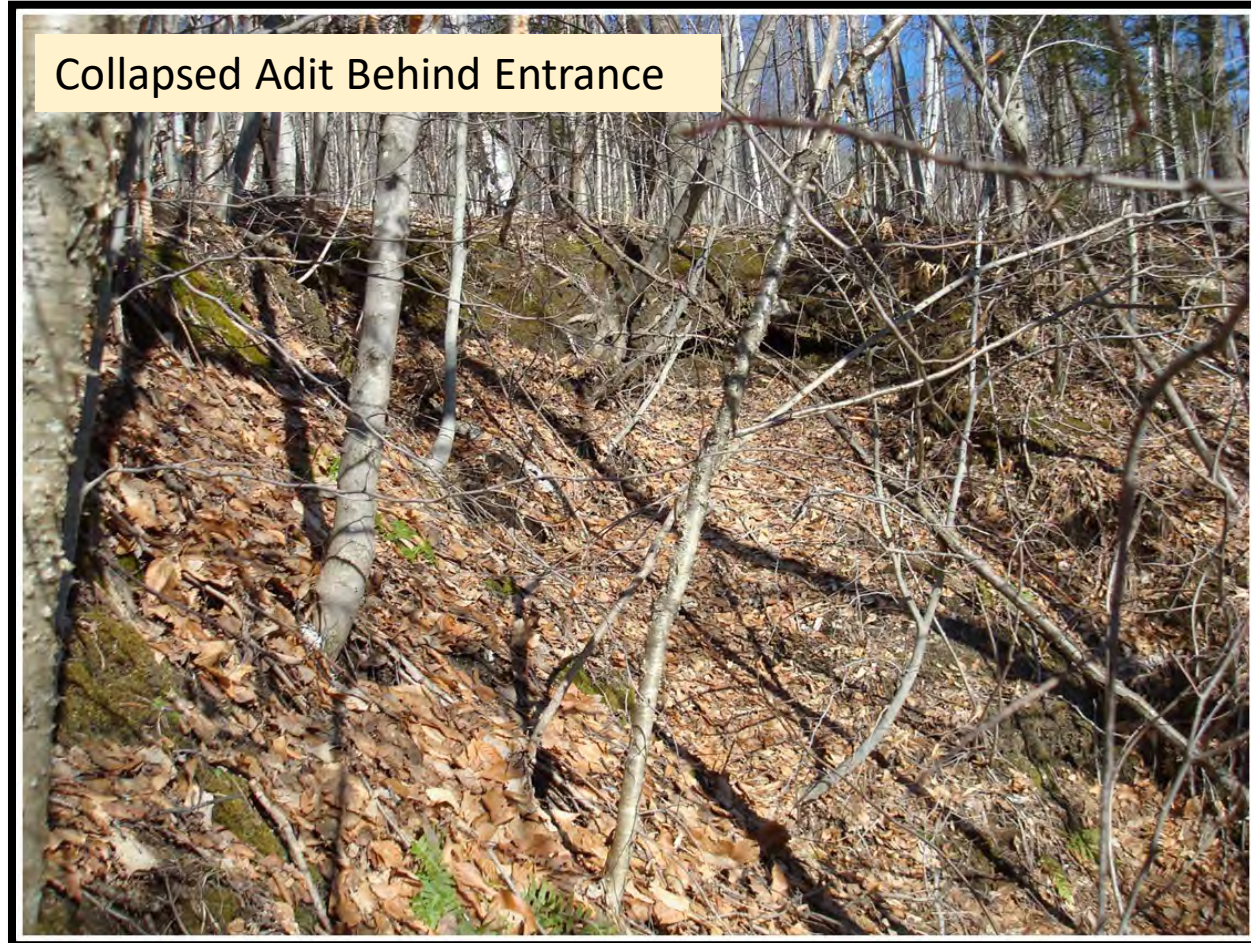
Collapsed Adit Behind Entrance

East-facing view of the collapsed portion of the 1898 Adit behind the portal.

Back side of historic stone portal

Roof Collapse area

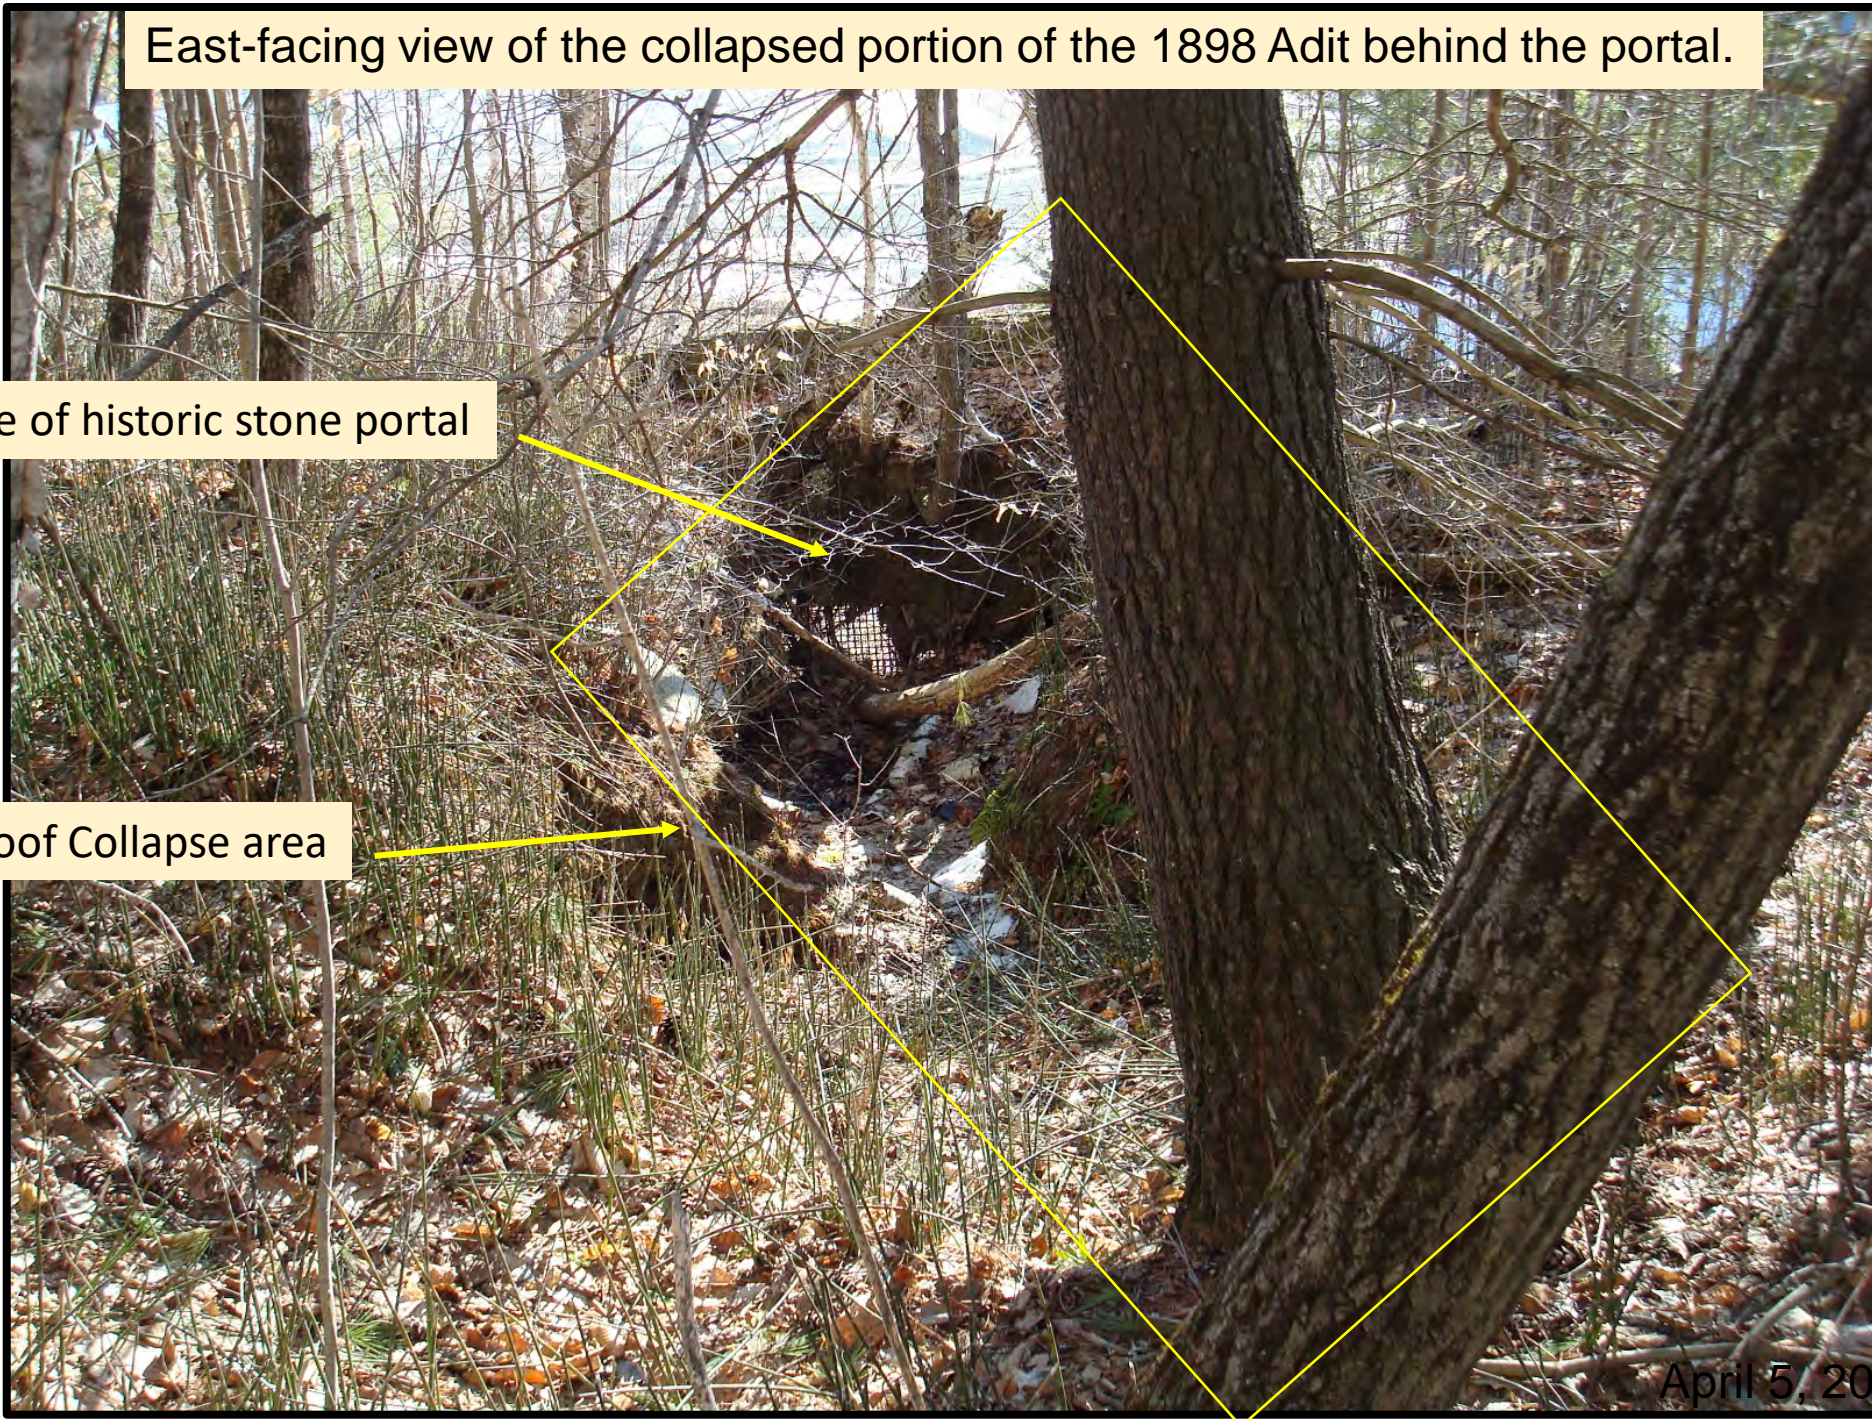
West-facing view of the area of subsidence upgradient of (adjacent to) the collapsed portion of the 1898 Adit.

Area with roof collapse

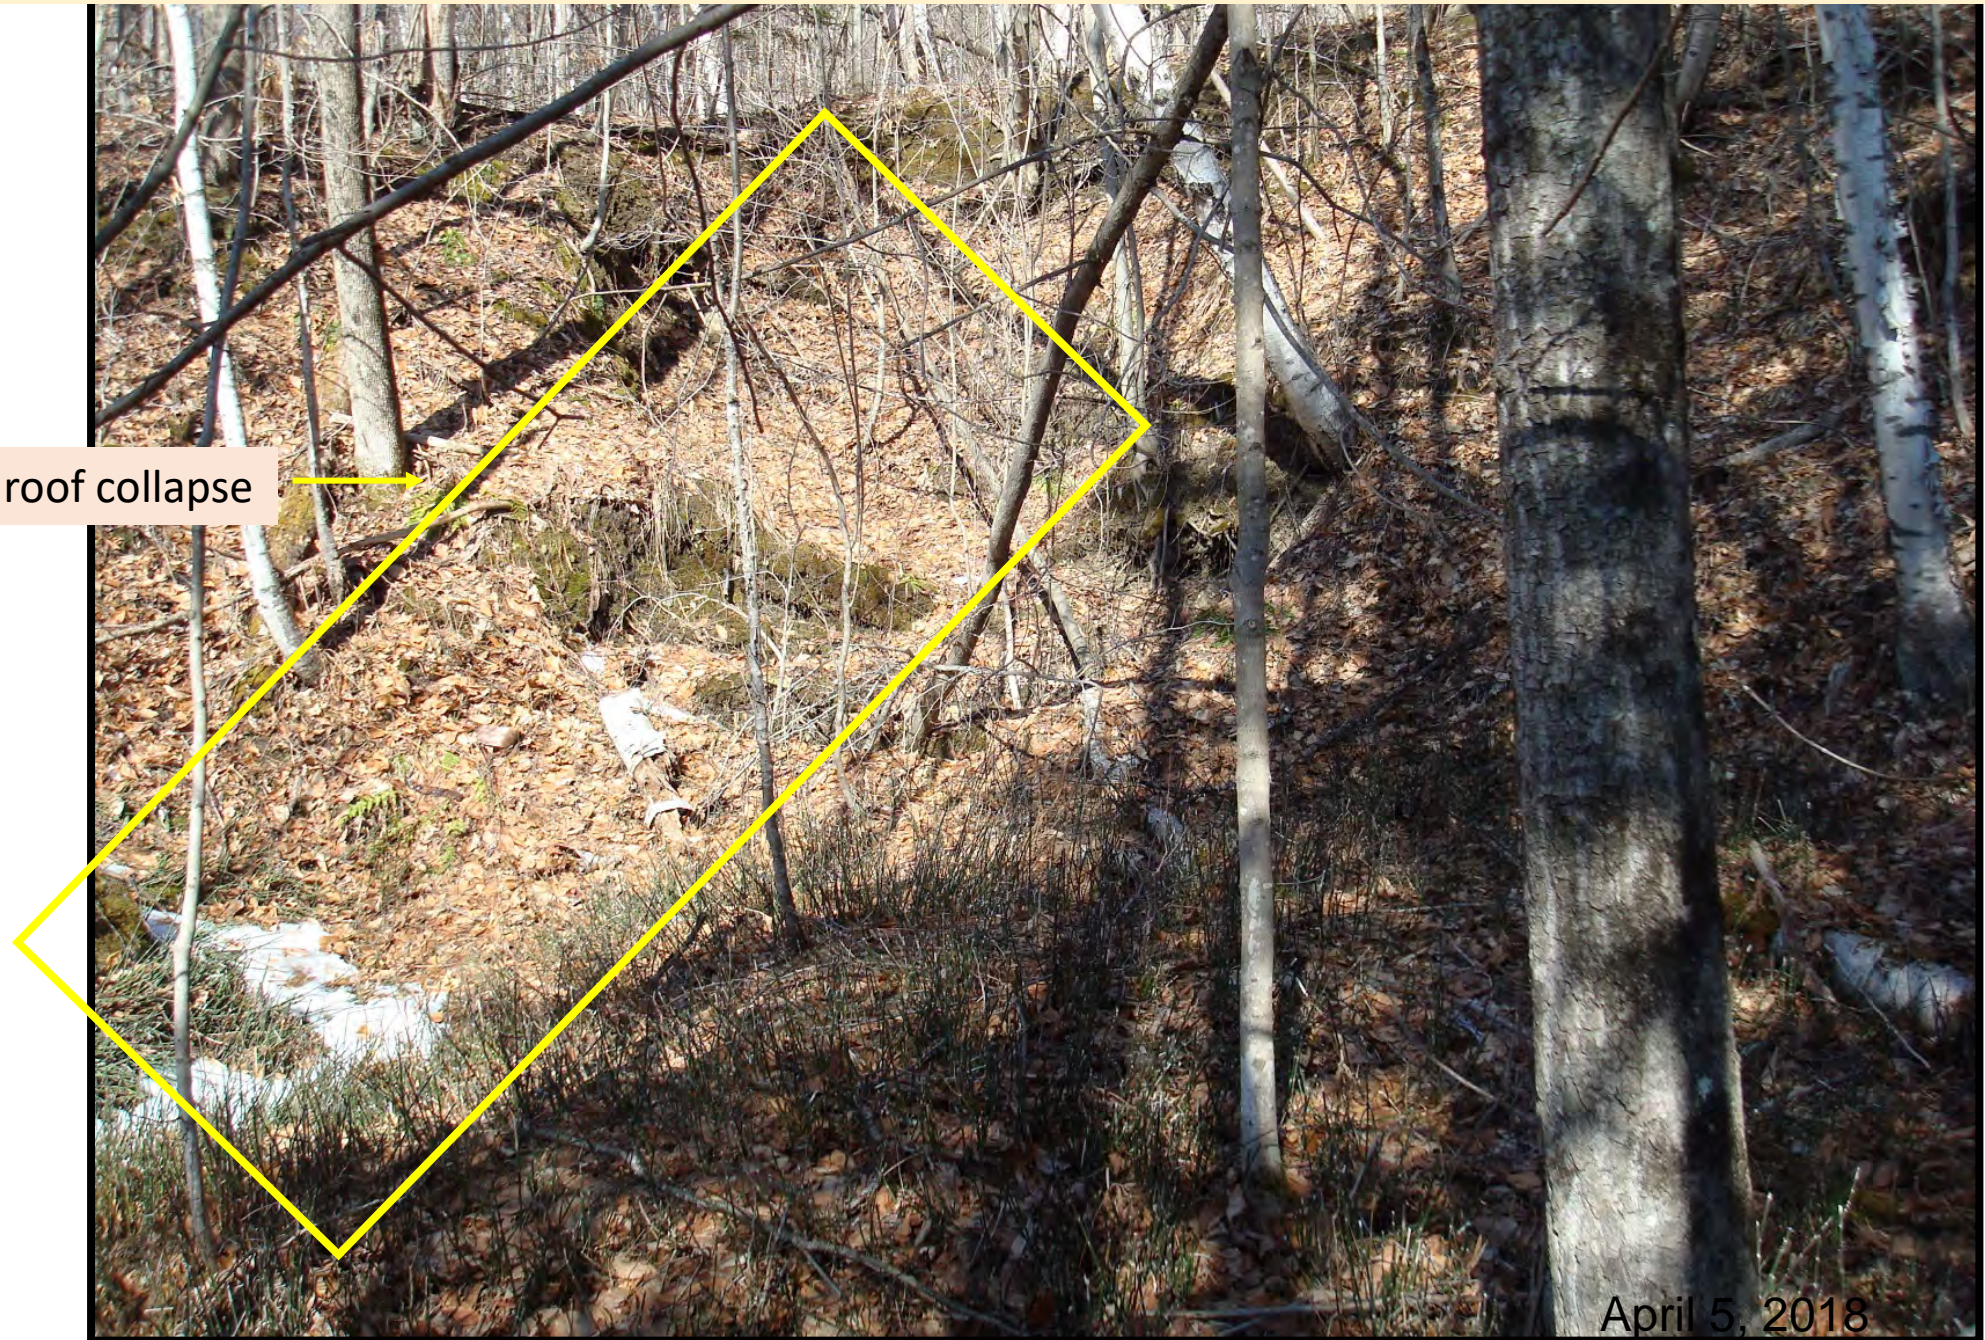
Close-up view of the area of subsidence upgradient of the collapsed area behind the 1898 Adit portal.

Area where roof collapse and historic excavation to install 1898 Adit co-occur

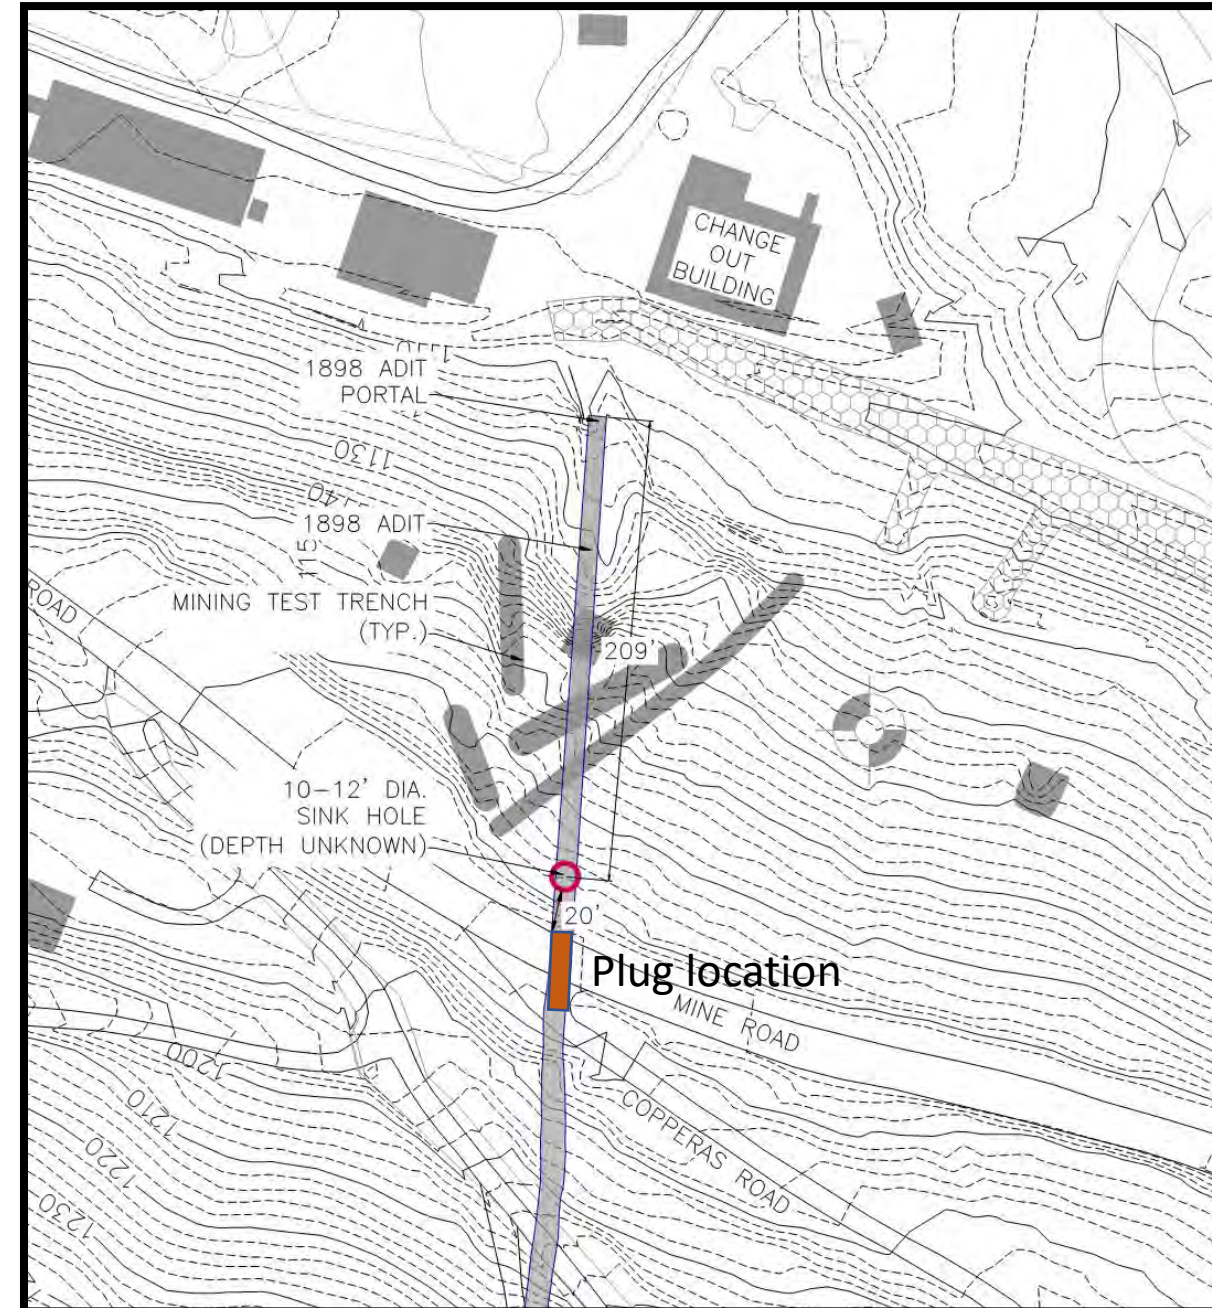
Sink Hole before excavation

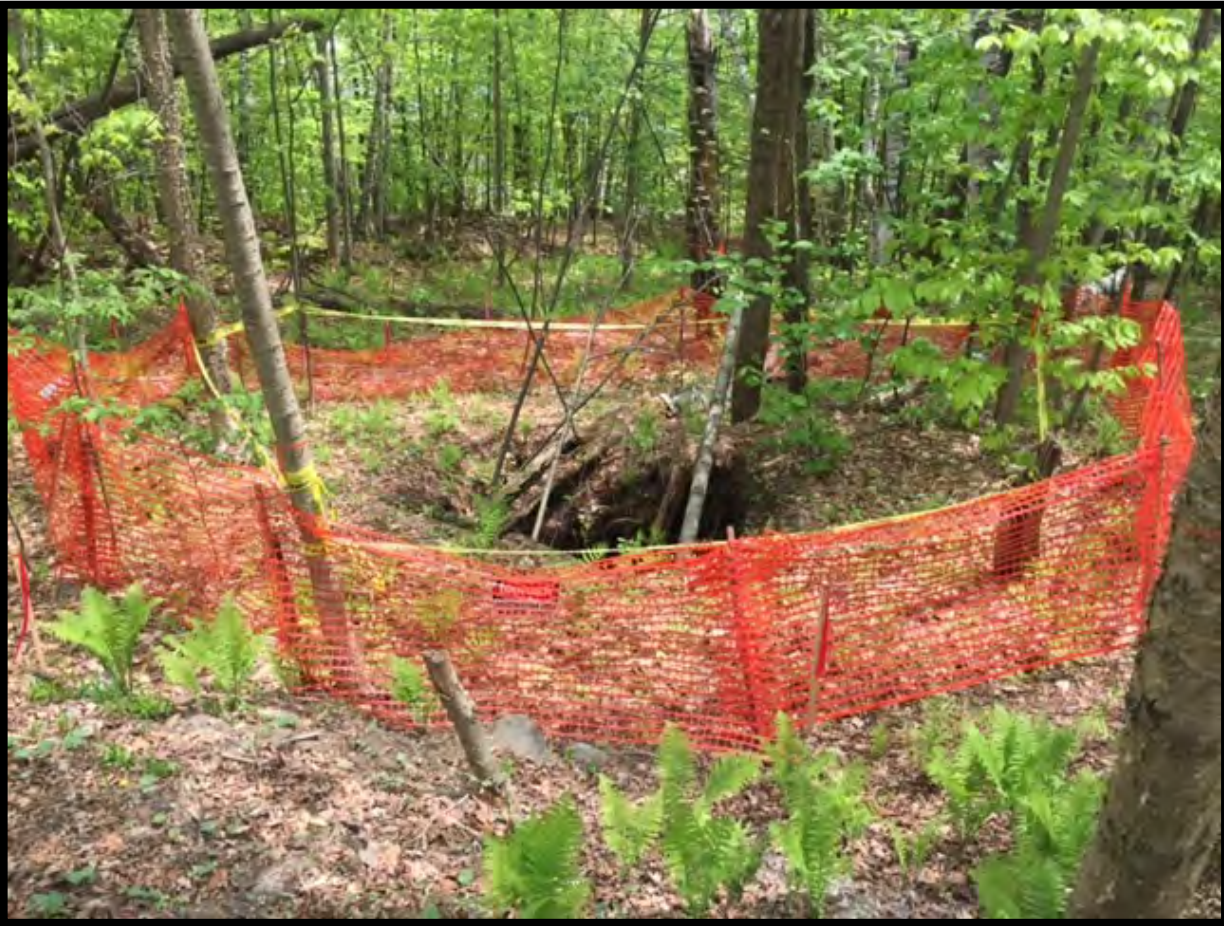
Sink Hole after excavation. The area within the hole was very large.

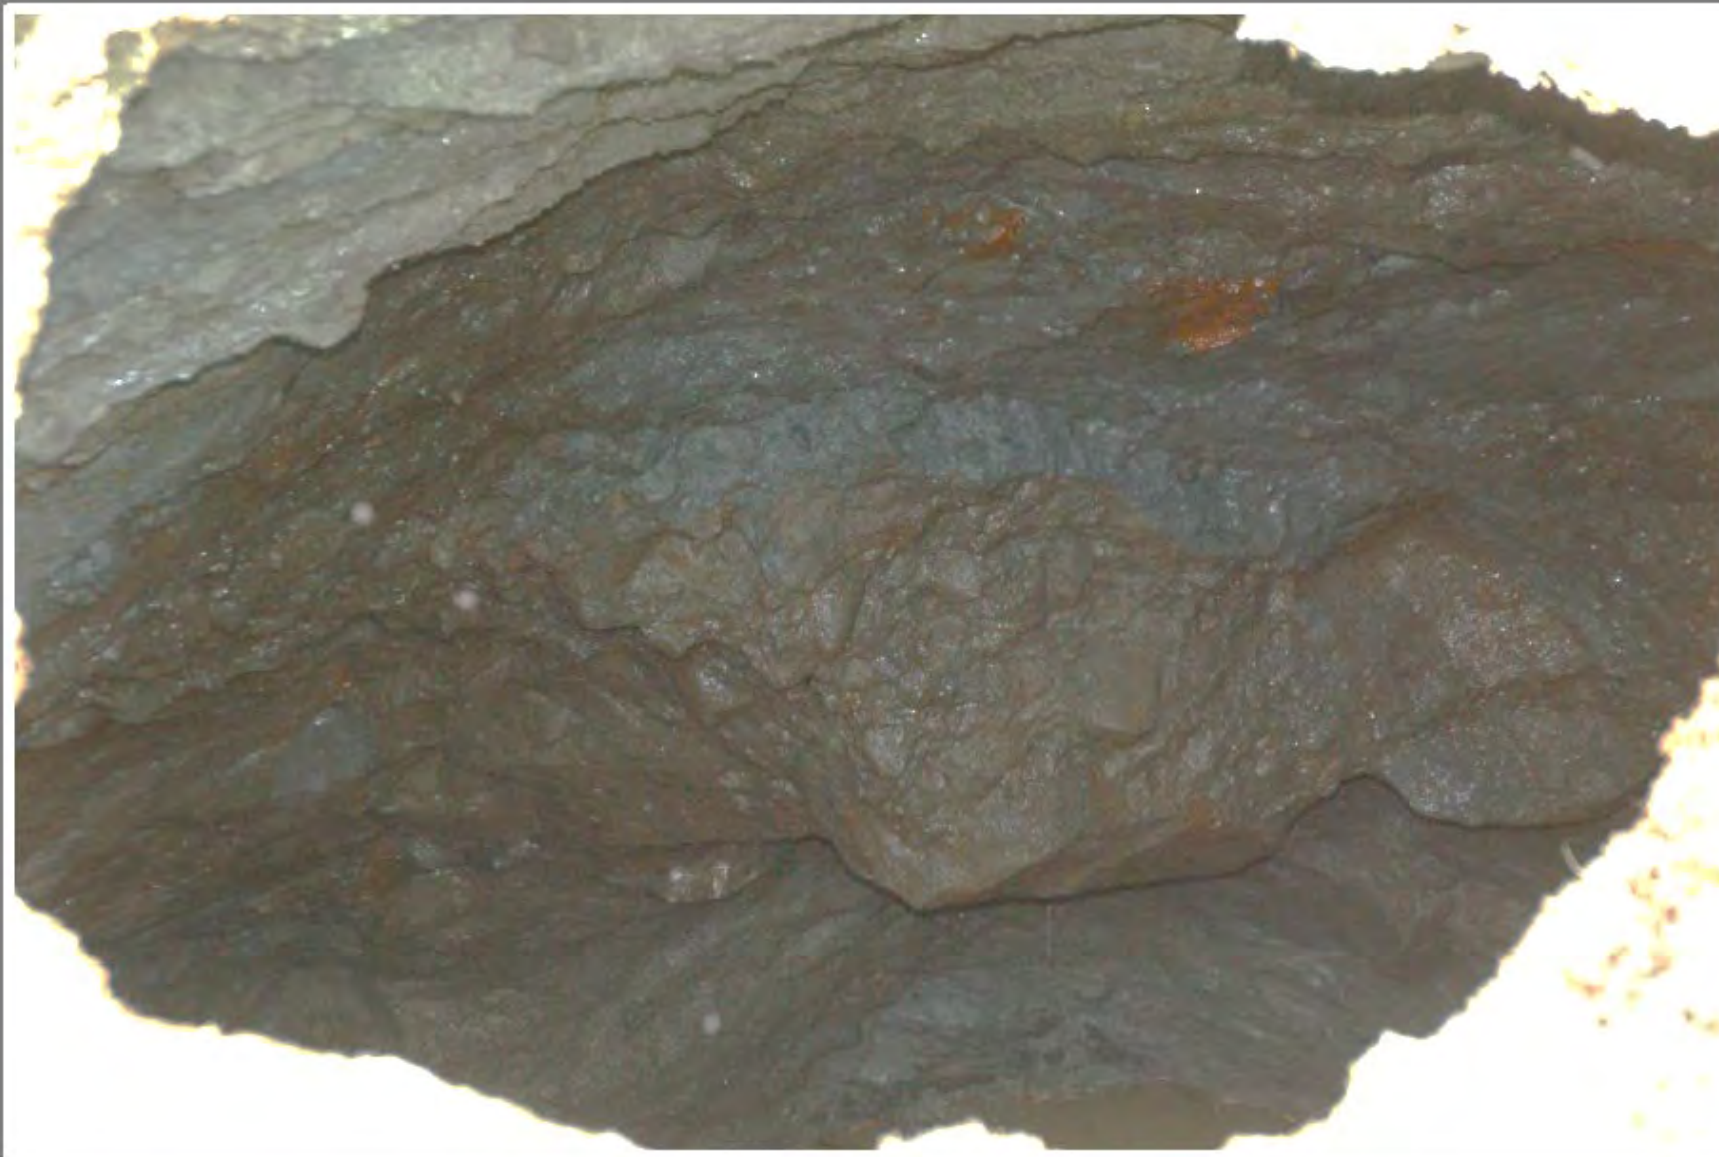
Close-up of the void/cavern discovered ~8' to 10' below ground surface.

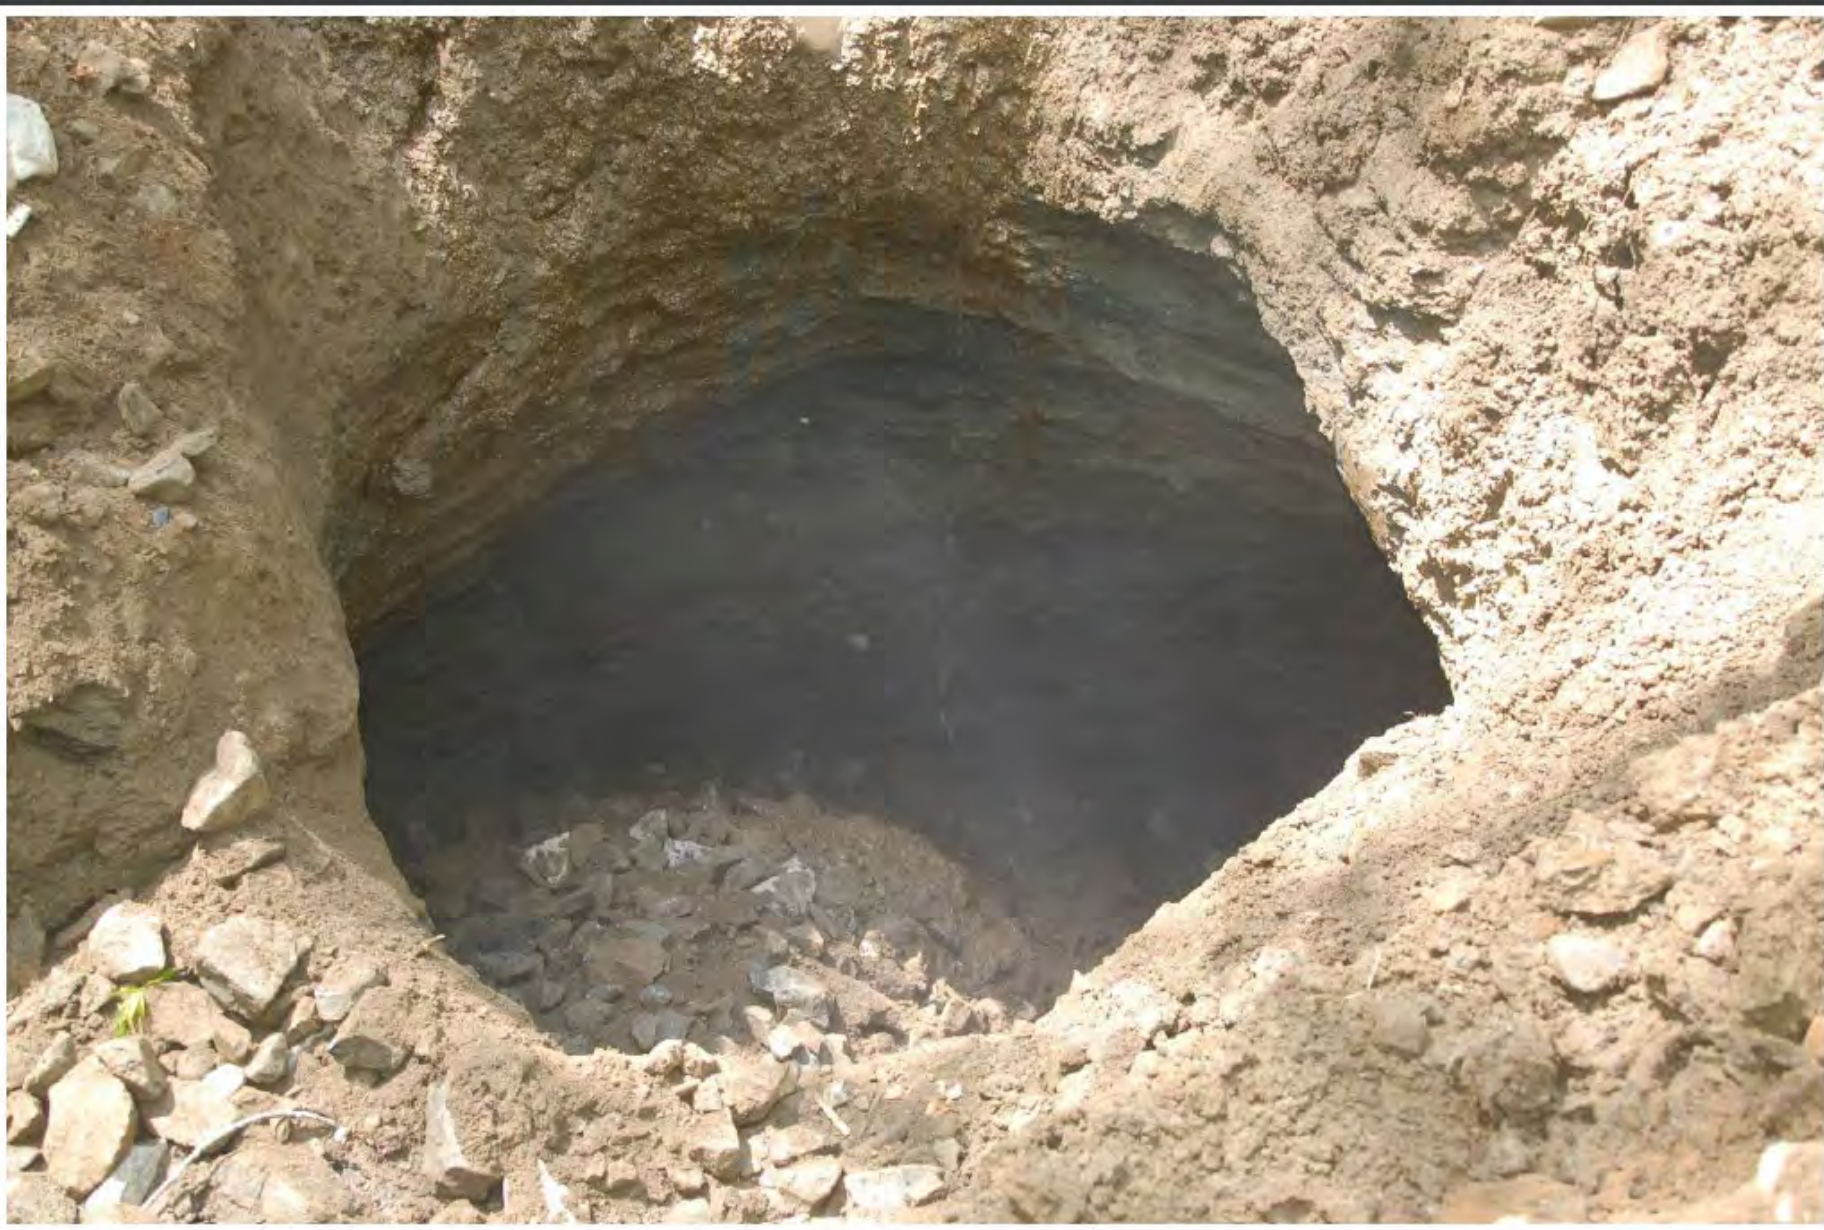
Close-up of 7" minus stone backfill in the void/cavern.

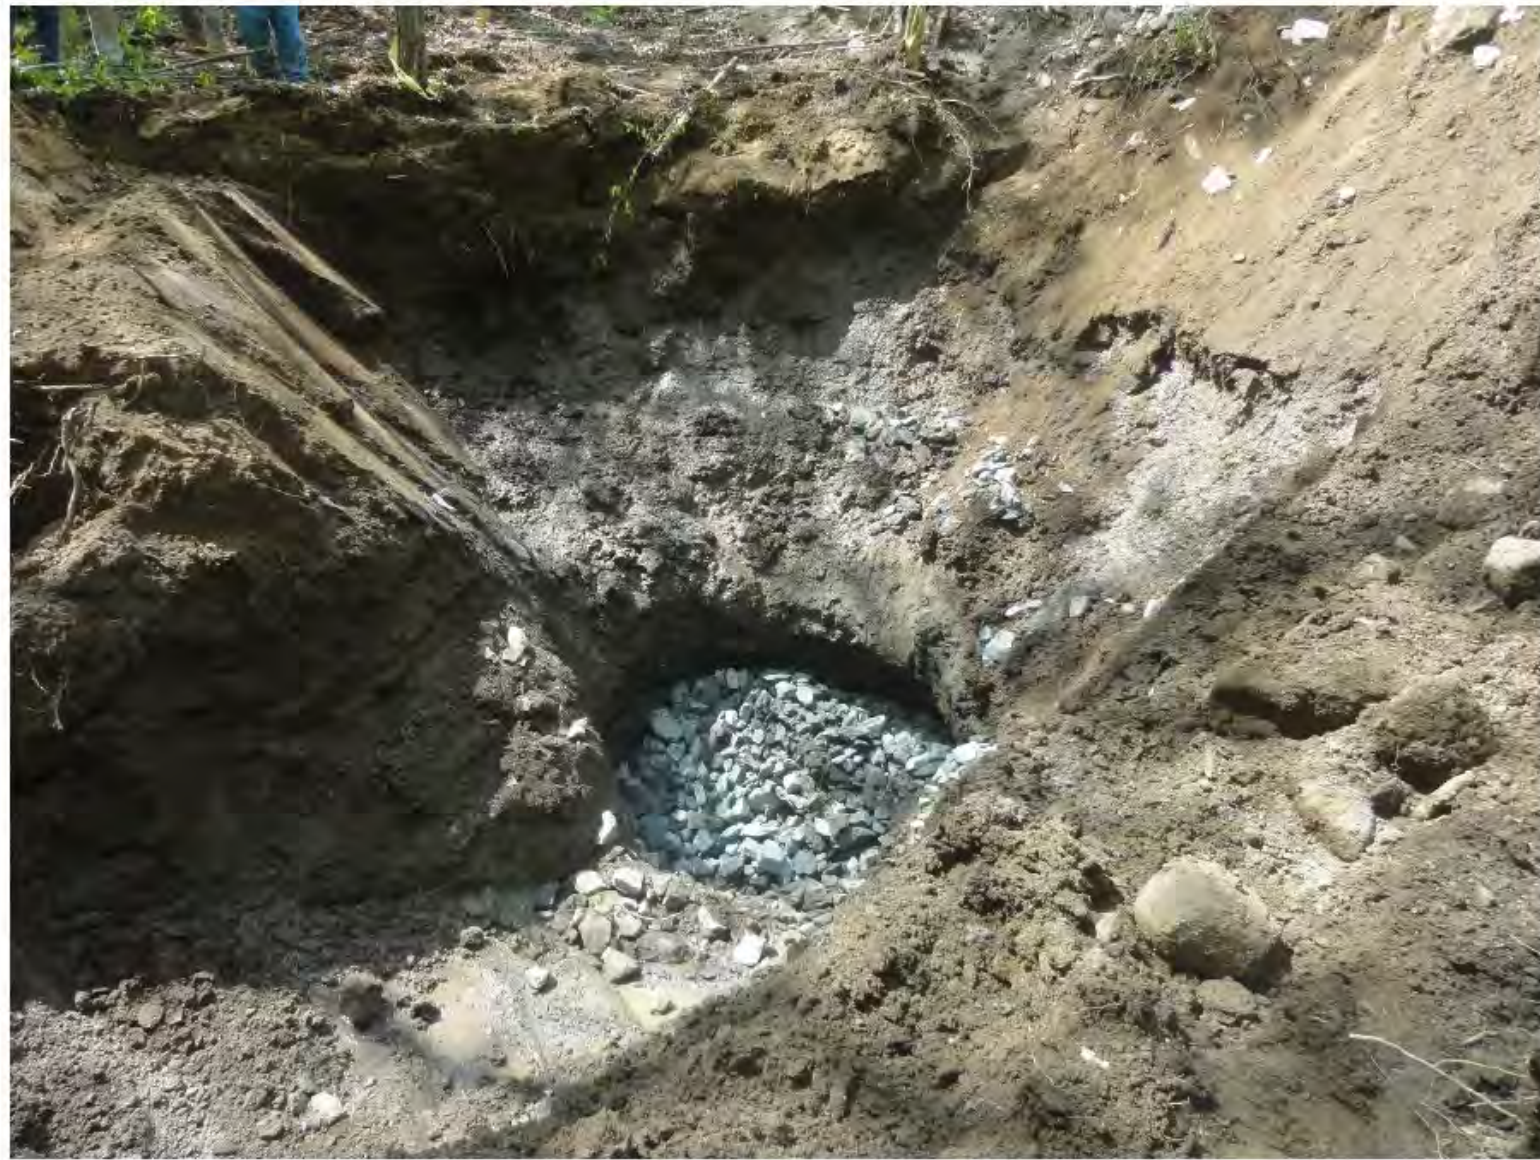
Another view of 7" minus stone backfill in the void/cavern.

Individuals and excavator are on the Town Road – note proximity
