November 9, 2021

Reference: Structural Inspection of Strafford Town office
227 Justin Morrill Highway, Strafford, Vermont

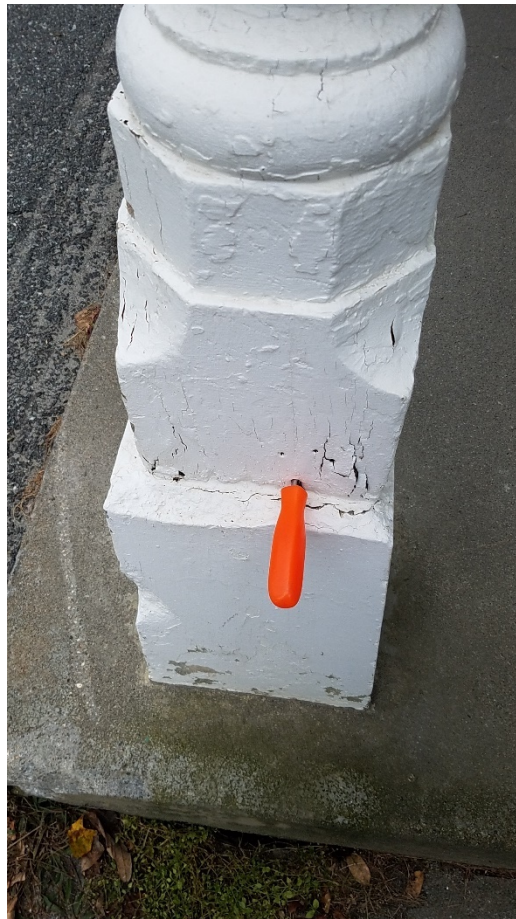
Photograph #1 – Porch post base rot

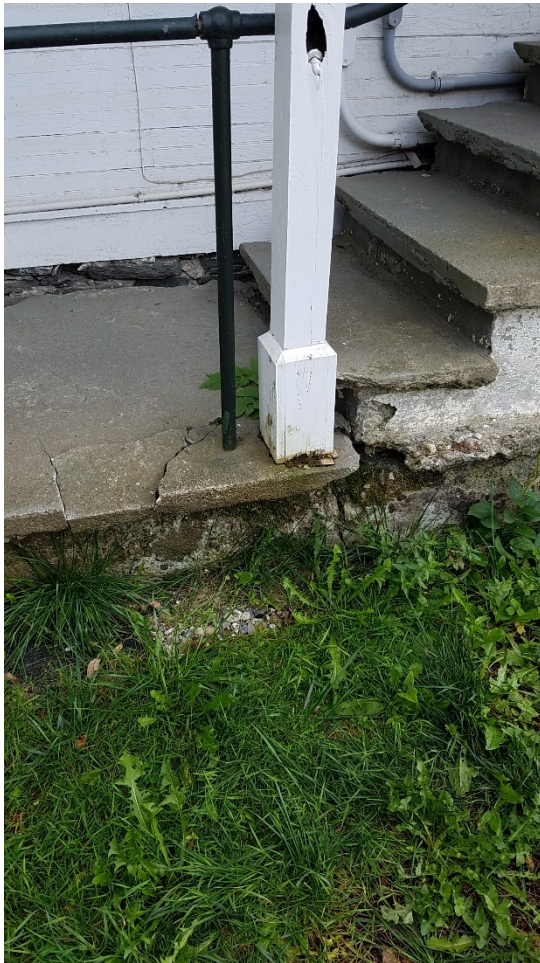
Photograph #2 – Post damage at north porch

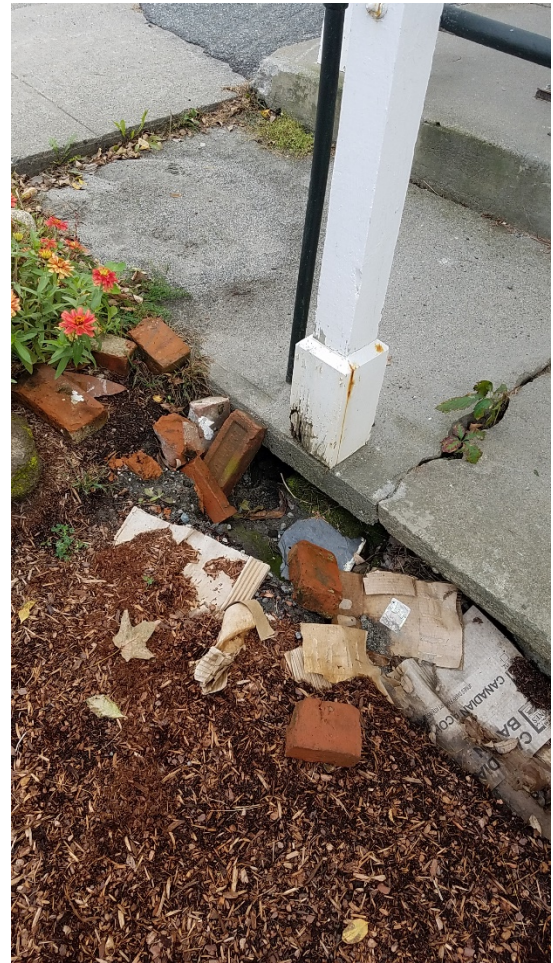
Photograph #3 – Post damage at north porch

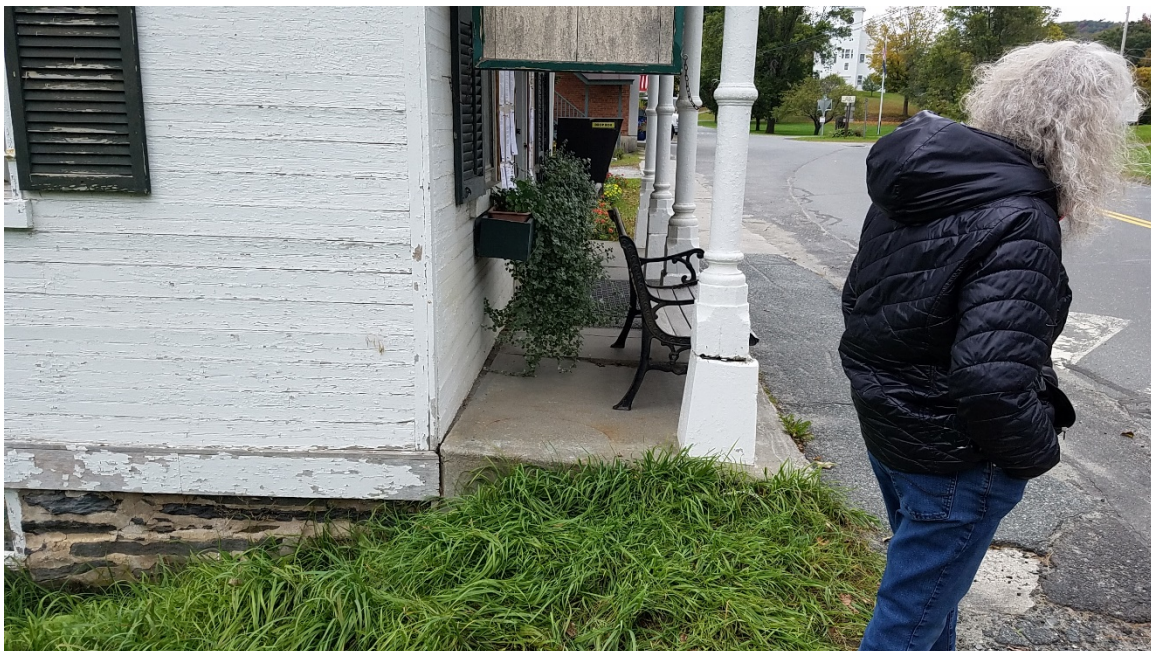
In addition to the north porch issues, the eastern entry porch has also degraded since my 2019 visit. Currently the porch posts have severe base rot and the front porch slab is heavily cracked. Furthermore, the sills and siding are buried below the front porch slab. Based upon the insertion of probes along the entry, it appears that sill rot has gotten significantly worse since the 2019 condition. In addition, it appears that regrading of the road shoulder to the northeast has directed additional water towards the porch, sill, and crawlspace.

Photograph #4 – Eastern porch slope, pier movement, sill buried in concrete.

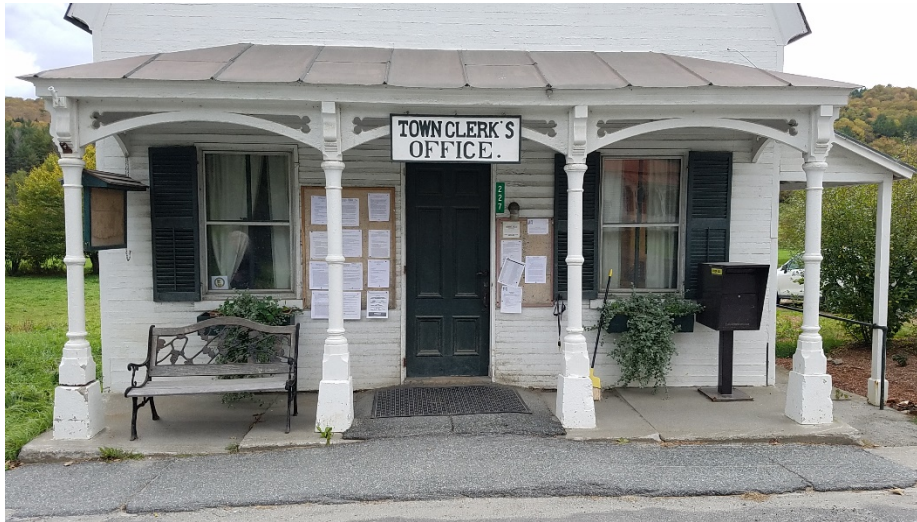
Photograph #5 – Eastern porch movement, eastern sill below grade, drainage towards building/crawlspace.

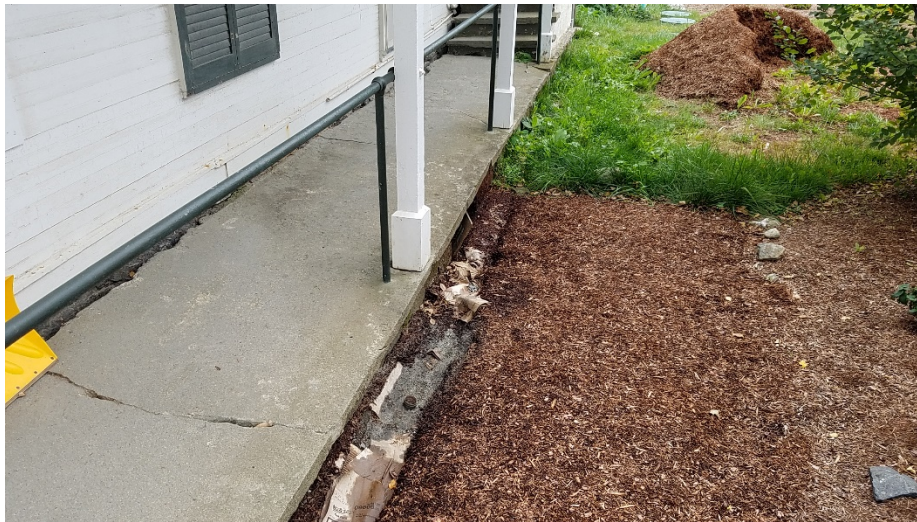
Photograph #6 – Drainage issues directed towards crawlspace access.

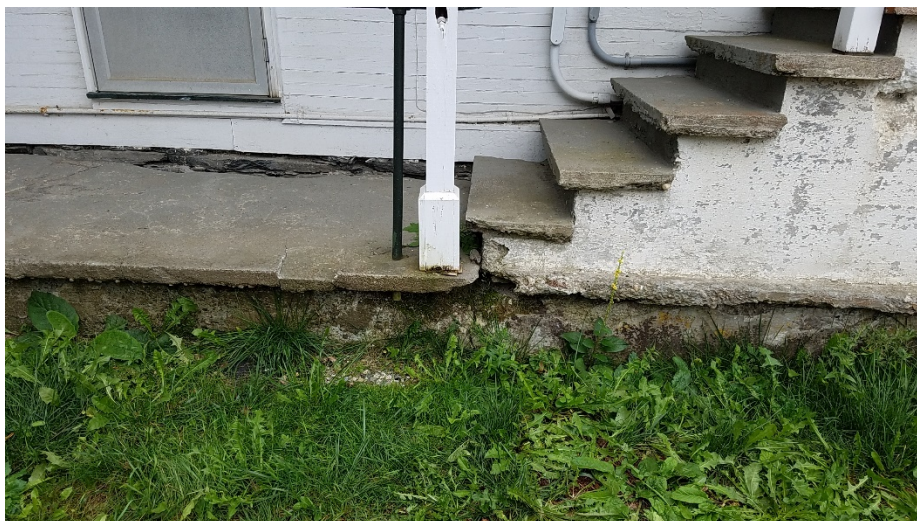
During review of the back-stair damage, I discovered that the north porch roof and the slab supporting it had both visibly degraded since my 2019 inspection. In my July 19, 2019 report concerning the building, the north porch was already in poor condition but at that time the porch was planned to be removed. The porch has continued to degrade and several of the posts are damaged and the exterior stair has continued to settle. In addition, grade against the building has been changed and as a result, water from a significant surface area is directed into the crawlspace. In our 2019 report we had recommended that the northern slab be removed and proper drainage provided to prevent further rot and water infiltration into the crawlspace. The current condition has made the crawlspace infiltration worse and has likely exacerbated rot and moisture conditions that already existing in the crawlspace.

Photograph #7 – Column and north porch support issues
