## Strafford Town Office

Strafford, Vermont

Reference: Structural Inspection of Strafford Town Hall Building

Reference: Structural Inspection of Strafford Town office Roof Damage  
227 Justin Morrill Highway, Strafford, Vermont

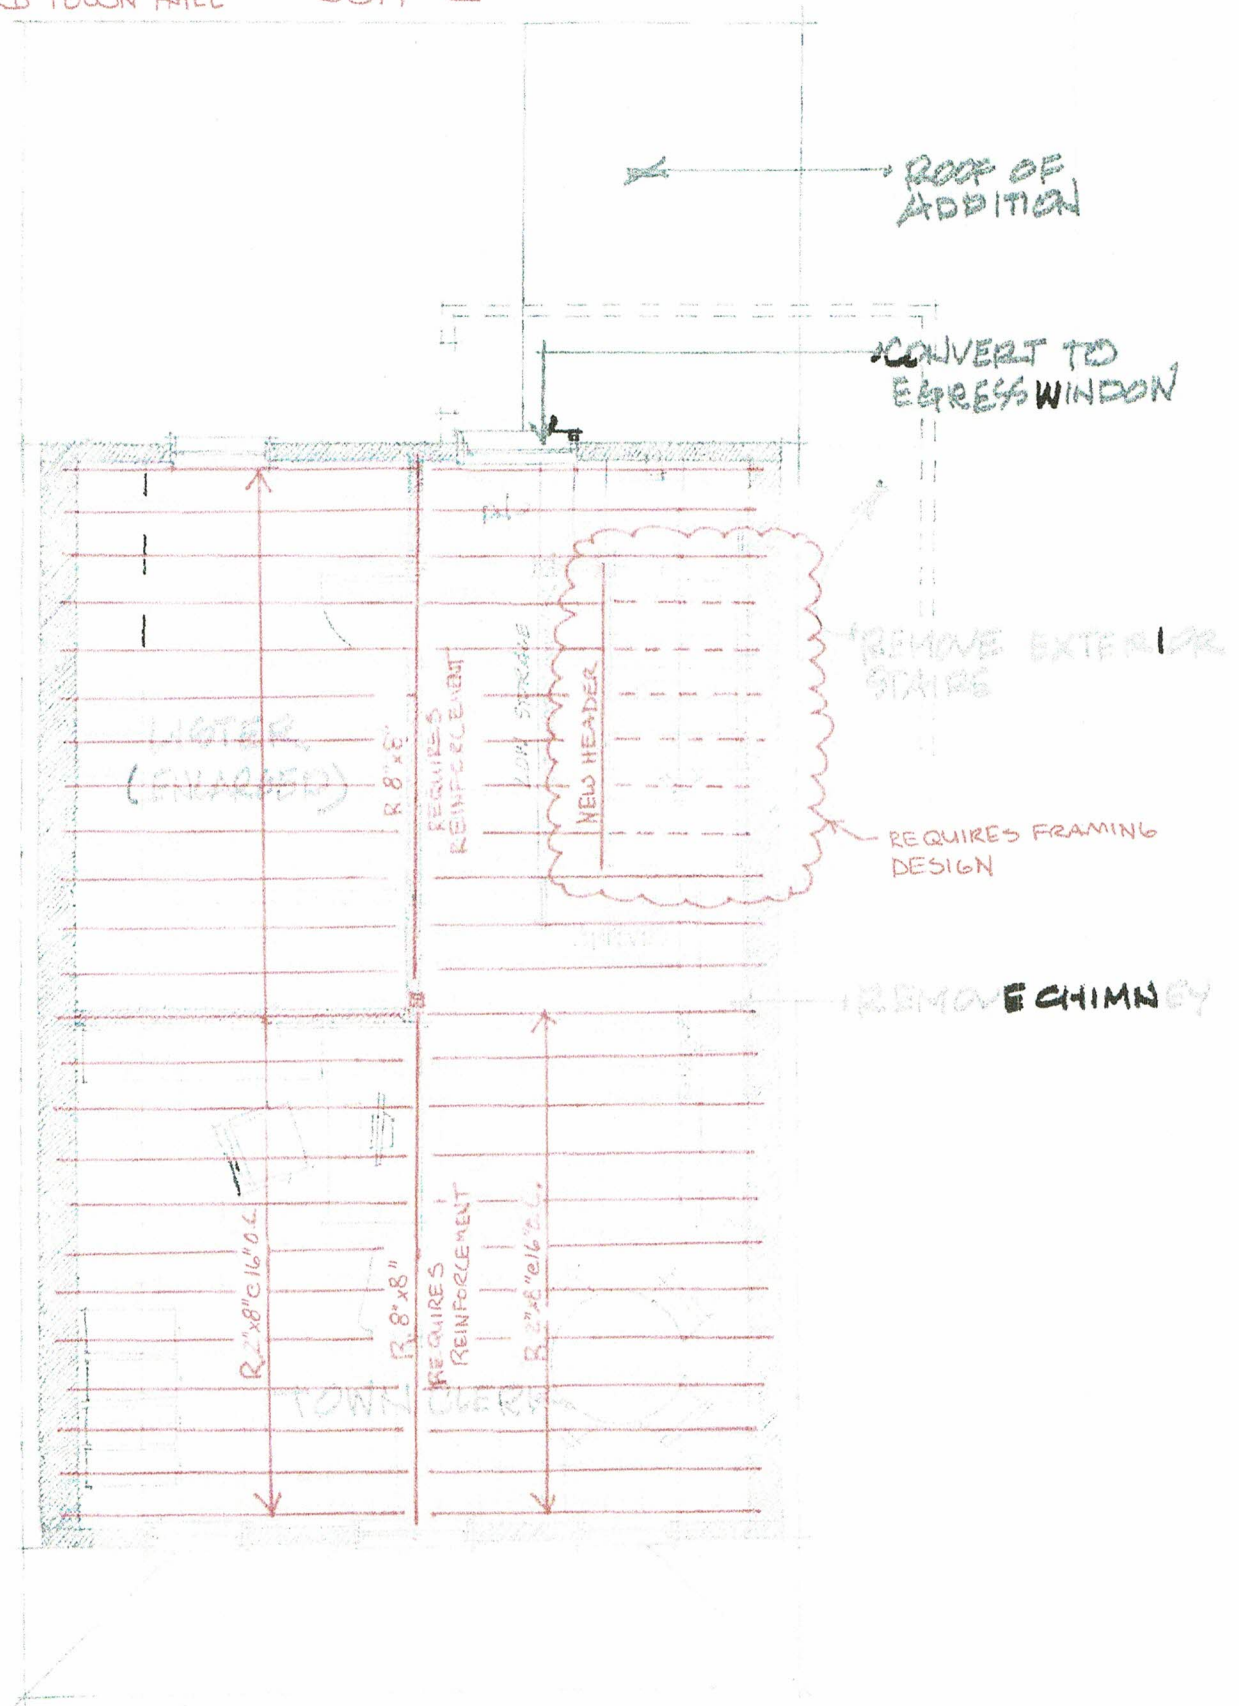
MOST RECENT VISIT BY DEWOLFE  
TO INVESTIGATE DAMAGE & FURTHER  
DETERIORATION.

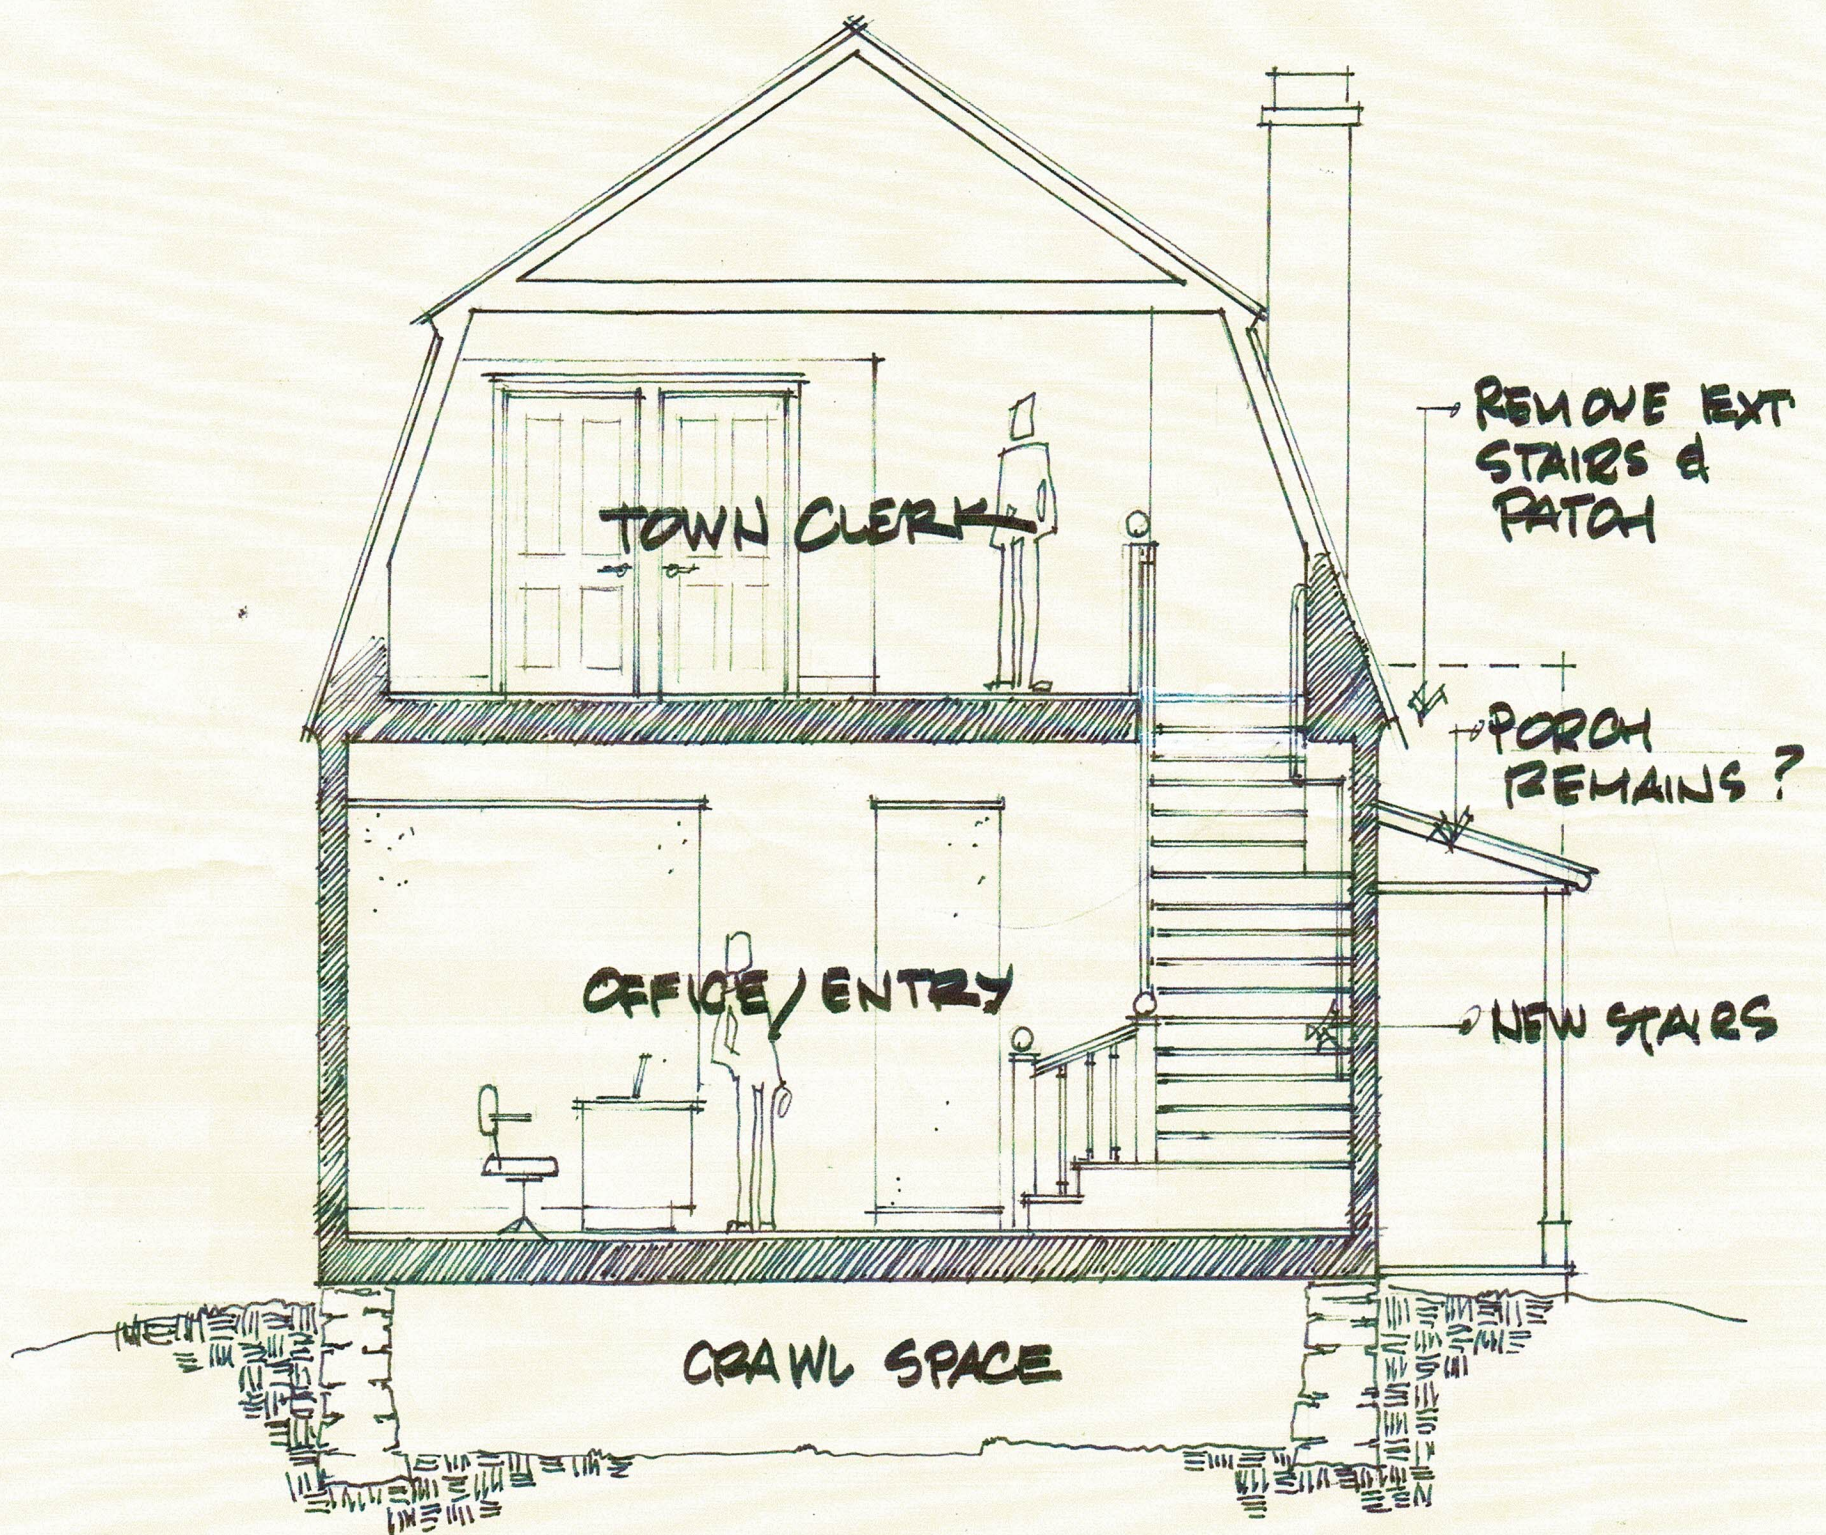
TDM: THIS IS FROM 2019 STUDY AND SHOWS  
SECTION THRU BUILDING. DISREGARD  
STAIR - STAIR IS NOW ANTICIPATED IN  
ADDITION
